**NASA Technical Memorandum 79178**

**AN EXPERIMENTAL, LOW-COST, SILICON  
SLURRY/ALUMINIDE HIGH-TEMPERATURE  
COATING FOR SUPERALLOYS**

**Stanley G. Young and Daniel L. Deadmore  
Lewis Research Center  
Cleveland, Ohio**

**July 1979**

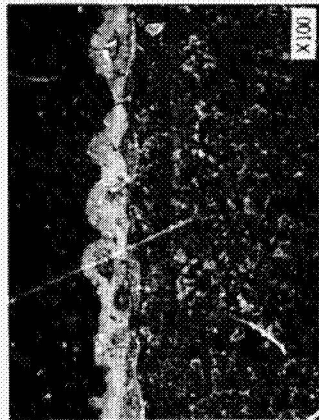
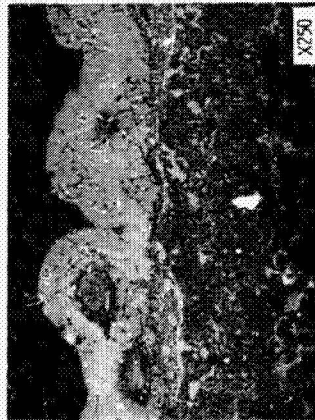
Figure 9. - As-coated Si-Al on alloy VIA.

Test coupons of the as-coated specimens and cross sections of the as-tested specimens were cut and mounted in standard metallographic mounts. Photomicrographs are shown in figures 9 to 12. Figure 9 shows the Si-Al on VIA alloy as coated; figure 10 shows the same alloy and coating after testing in the Mach 1 burner rig for more than 1000 hr at 1093° C. Figure 11 shows the coating on B-1900 alloy, and figure 12 shows the coated B-1900 system after 2000 hr of cyclic testing.

Returning to the as-coated VIA specimen of figure 9, two distinct layers were observed above the VIA substrate. The inner layer is what remains of the original silicon-sprayed layer after the 16-hr pack treatment. This layer appeared as a multiphase, multielement region of small elongated grains. This layer was highest in nickel, then silicon, with widely varying amounts of the other elements. One interesting aspect of this study was that silicon diffusion into the base metal was very slight (much less than expected) but that silicon diffusion outward was significant. The top layer was mostly NiAl, which contained nodules of the silicon-rich phase and, as a result, formed an unusual pebb'y textured surface. These nodules may have been the result of silicon particle agglomeration in the spray process. However, the surface appeared to be covered relatively uniformly with these rounded grains that had an estimated average diameter of about 100  $\mu$ m. After exposure, this surface tended to become smoother, yet, this pebb'y texture remained long into the tests.

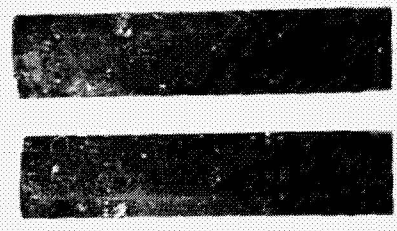
(a) Exposure, 238 Hrs.

(b) Exposure, 345 Hrs.

Figure 16. - Photomicrographs of Si-Al on B-1900 specimens after Mach 0.3 hot-corrosion tests at 900°C with sea salt.

Figure 15 shows the appearance of the bare specimens after 105 hours of test and illustrates the severity of the hot corrosion process to this alloy. Figure 16 shows the coated specimens at various times to the end of the test. Note that blisters formed after 345 hr. Hot corrosion occurred at these spots and essen-

tially made deep holes in the specimens by 779 hours. Although the long-time specimens appear bad from the photographs, the coating actually provided relatively good resistance for such a severe type of test.
